**GLADSTONE CITY COUNCIL
ADJOURNED MEETING
CITY HALL COUNCIL CHAMBERS
November 25, 2014**

Library/City Hall/Police Station Proposal

ROOF EVALUATION REPORT

Evaluation of existing roof and flashing systems at the City
Hall in Gladstone, Oregon

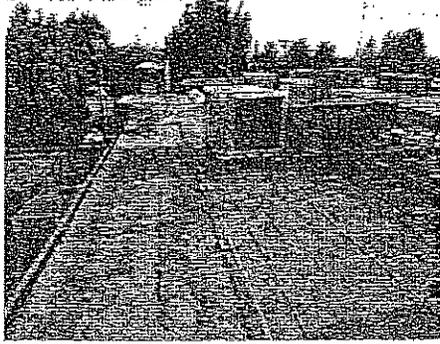
1.1

Overall view of roof membrane and rooftop equipment looking east.

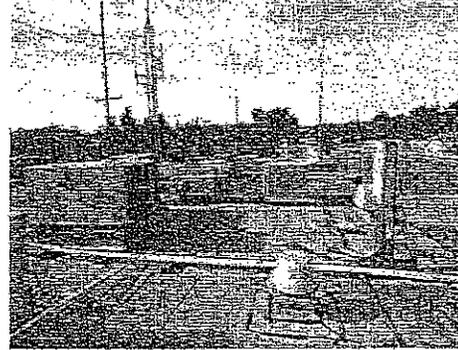
1.2

Overall view of the roof membrane and rooftop equipment looking west.

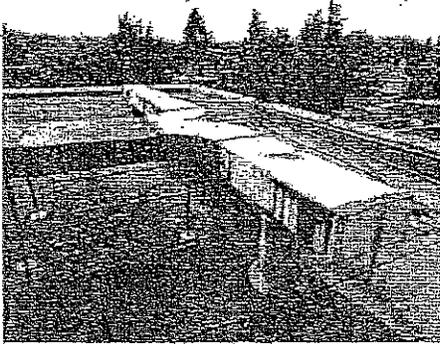
1.3

Duct work located at the roof level is deteriorated.

2. Install polyurethane sheet metal repair to all duct work seams.
3. Install plastic cement at the base of all roof penetrations and set an SBS flashing sheet over bed of plastic cement. Apply granules over all exposed plastic cement.
4. Clean gutter of all debris. Apply polyurethane seam repair to all gutter seams.
5. Top off all pitch pan penetrations with plastic cement; create dome to shed water.
6. Install new sealant at all sheet metal flashing seams and openings; tool sealant to drain.

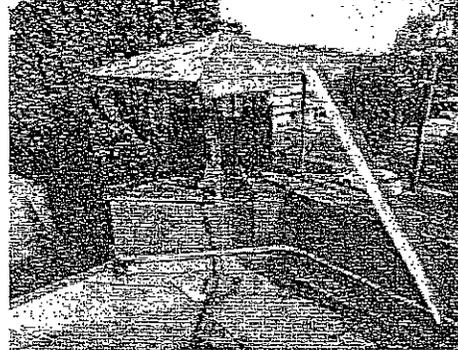
1.4

Roof mounted siren with temporary support bracing for the siren's roof cover.

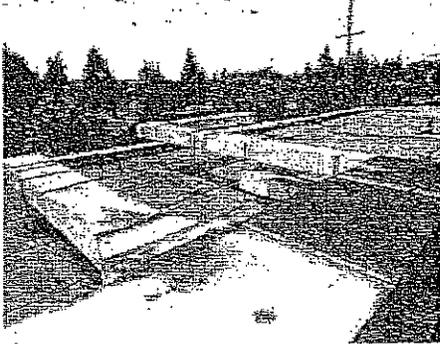
1.5

View showing deteriorated duct work and the numerous repairs that have been installed.

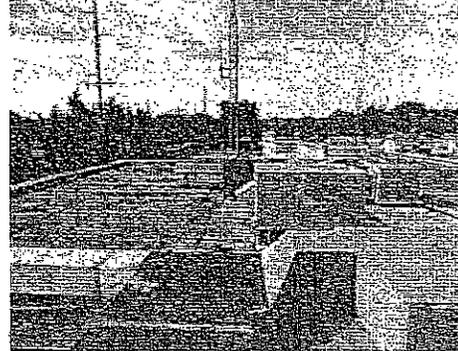
1.6

Photo looking west of the many rooftop equipment penetrations.

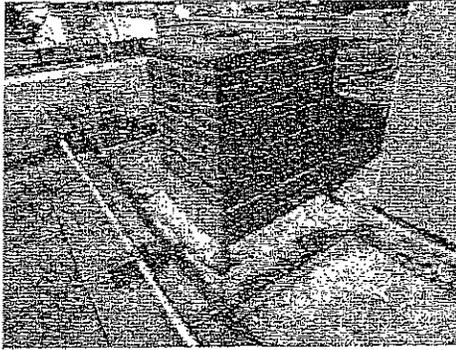
1.7

Chimney penetration located between HVAC equipment.

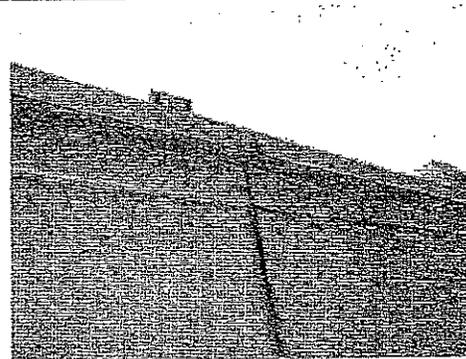
1.12

View from under gutter assembly showing leaking seam and damage to building exterior.
