SOIL BORING LOG

PROJECT TRI CITY STP LOCATION OREGON CITY, OREGON
 DRILLING METHOD MUD ROTARY DRILLERS & EQUIPMENT D. KENNER OF OREGON, INC
 ELEVATION 42.50 FT BORE HOLE: B-11
 WATER LEVEL SEE TEXT DATE: _____ START: 12/28/81 FINISH: 12/28/81 INSPECTOR C. UHL

<p>15575 SW Sequoia Parkway - Suite 100 Portland OR 97224 Off 503.968.8787 Fax 503.968.3068</p>	BROWNCALD-49-03	VICINITY MAP	
	MARCH 2011	PROPOSED CLACKAMAS RIVER INTAKE PUMP STATION GLADSTONE, OR	FIGURE 1

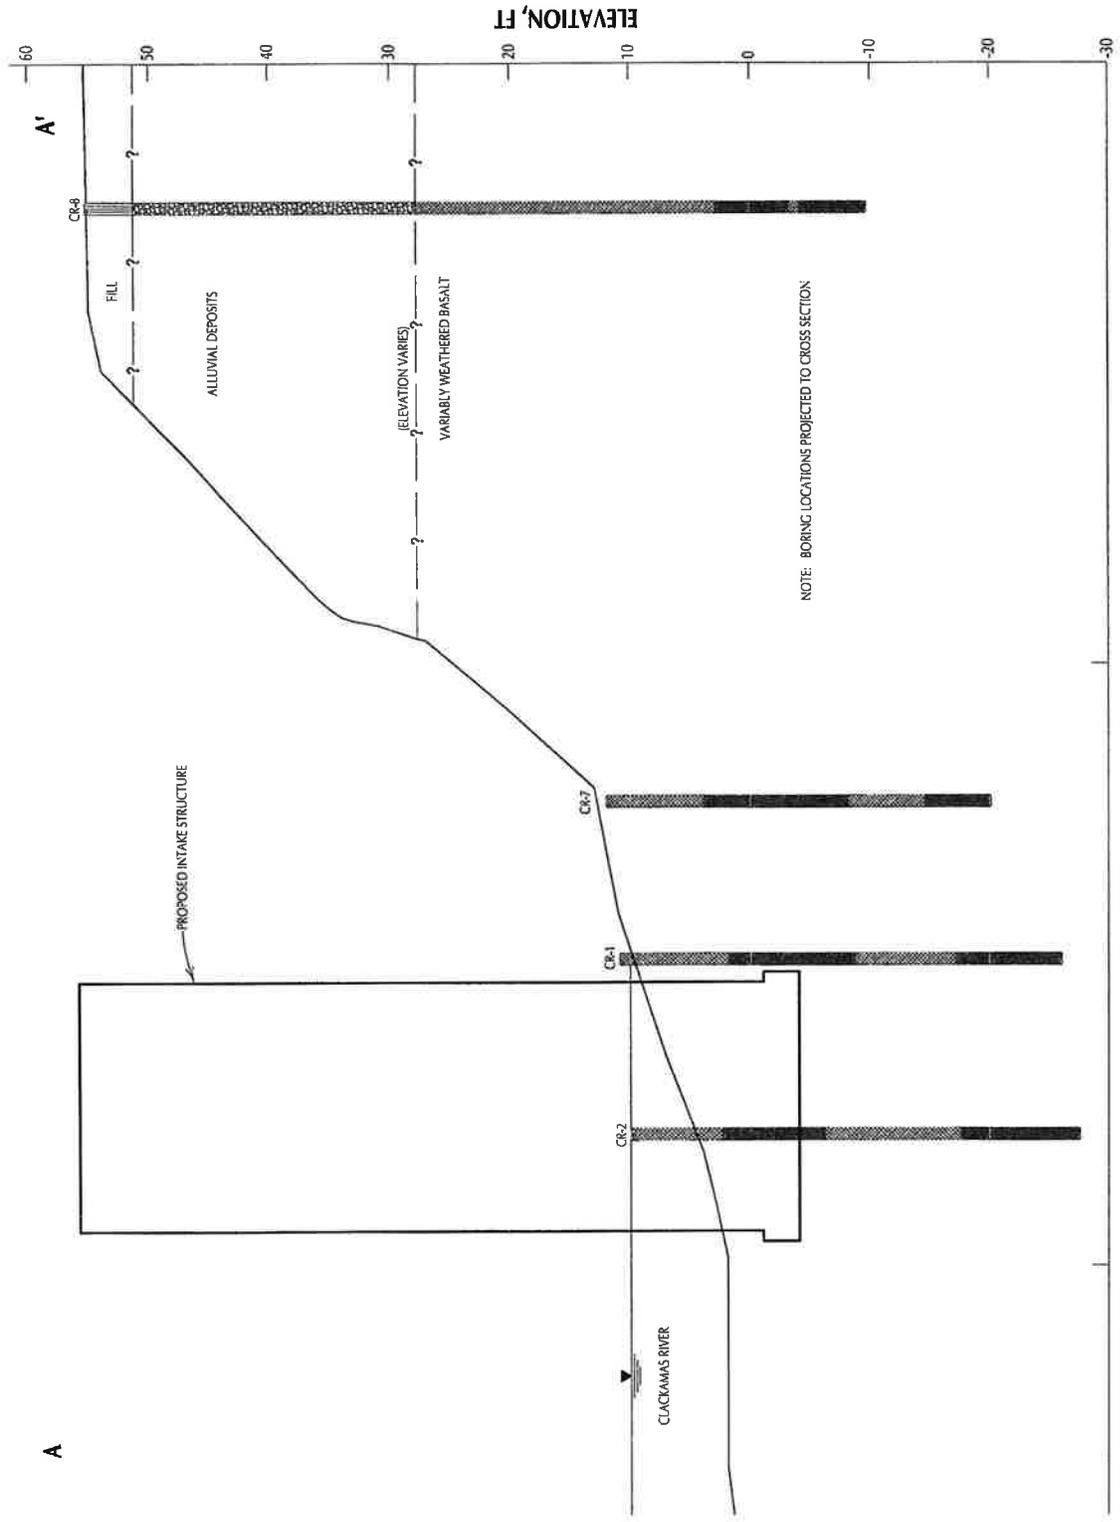
- FILL
 - ▨ ALLUVIAL DEPOSITS
 - ▤ (R0 - R2) EXTREMELY SOFT TO SOFT BASALT
 - ▥ (R3 - R5) MEDIUM HARD TO VERY HARD BASALT
- CROSS SECTION FROM FILE BY RESOURCE CONSULTANTS, INC. (UNDATED)

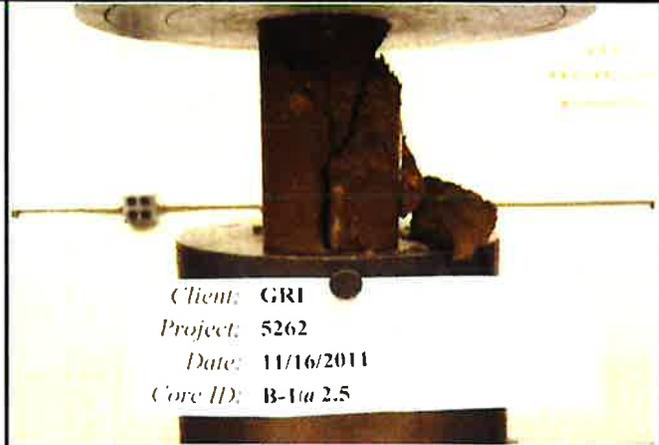
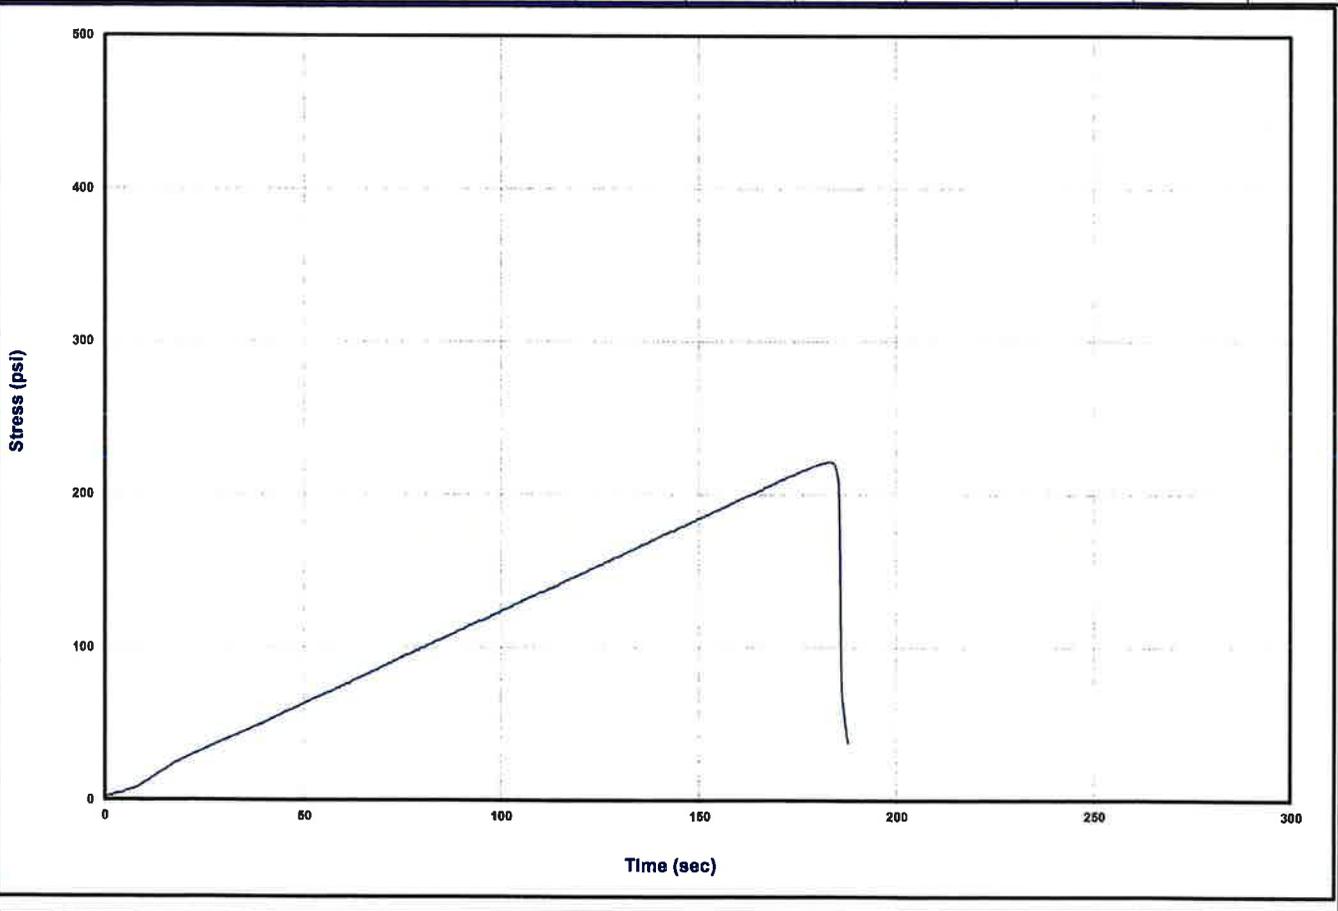
Client: GRI
 Project: 5262
 Date: 11/16/2011
 Core ID: B-1@2.5

Client : GRI
 Project : 5262
 Location : N/A
 Rock Type : Weathered
 Rock Name : N/A
 Characteristics : N/A
 Core ID : B-1@2.5
 File Name : B-1@2.5_UCS
 Test Performed by : EAS
 Date Tested : 11/16/11
 Data Reduced by : EAS
 Date Reduced : 11/28/11

Core Length		Diameter		L/D	Failure Load	Failure Stress	UCS 2:1		Failure Mode		
in	cm	in	cm	Ratio	lbs	psi	psi	MPa			
4.006	10.18	2.090	5.31	1.92	759	221	222	1.5	Non-Structural		
P-wave		S-wave		Dynamic E		Dynamic	Static E		Static	Density, ρ	
ft/sec	m/sec	ft/sec	m/sec	ksi	GPa	ν	ksi	GPa	ν	lb/ft ³	g/cm ³
N/A	N/A	N/A	N/A	N/A	N/A	N/A	N/A	N/A	N/A	109	1.75

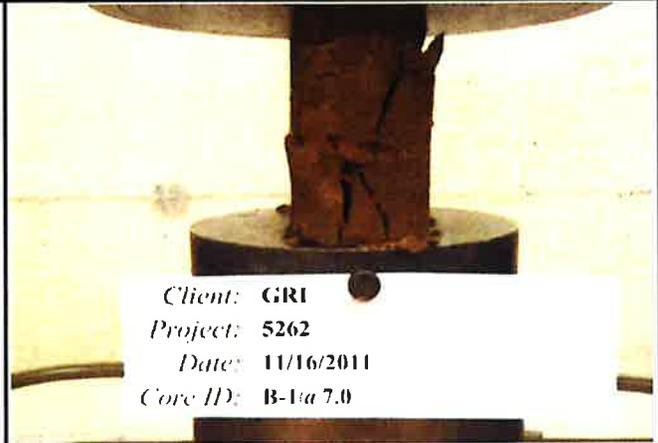
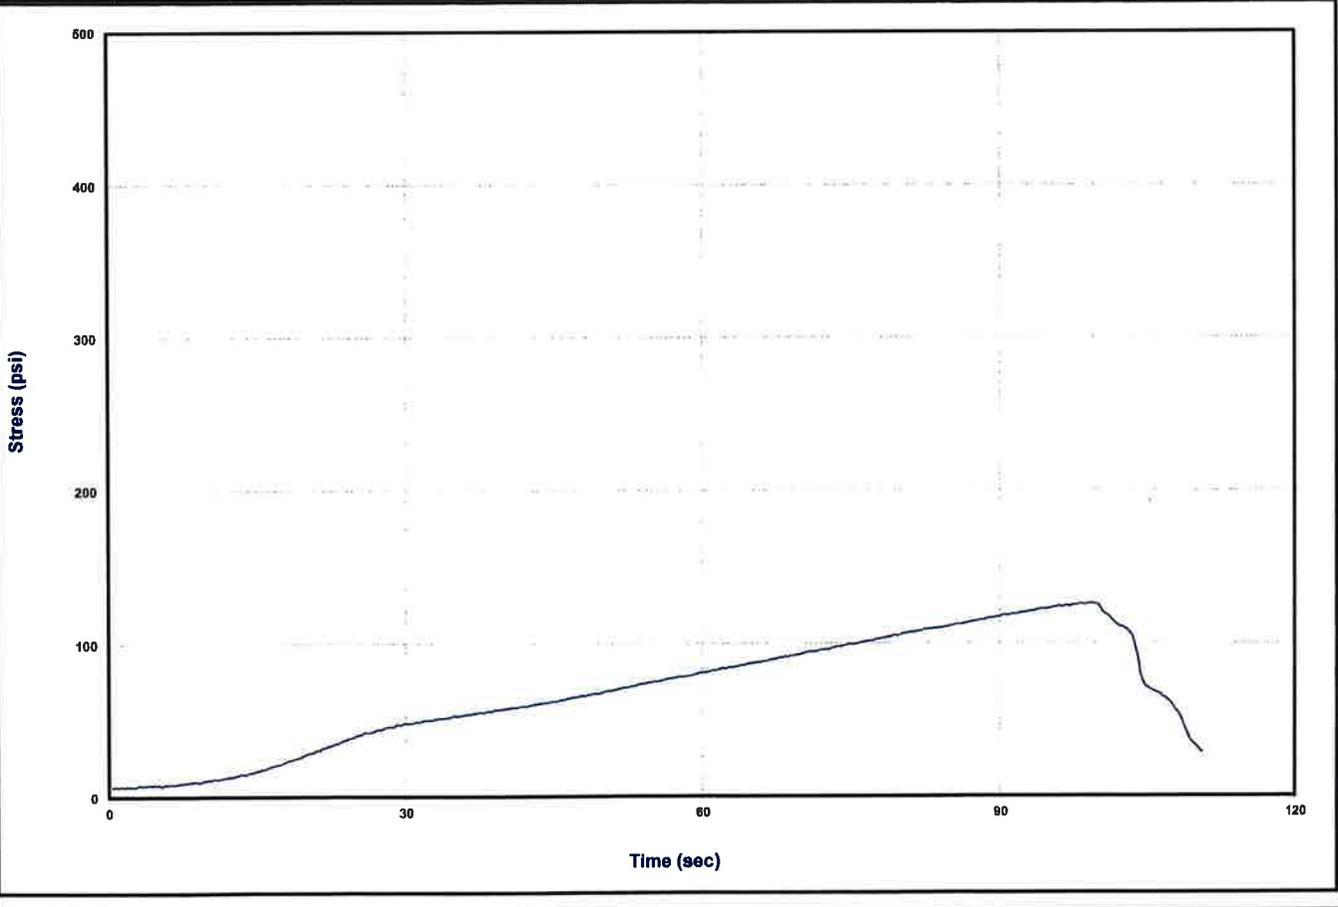
Client : GRI
Project : 5262
Location : N/A
Rock Type : Weathered
Rock Name : N/A
Characteristics : N/A
Core ID : B-1@7.0
File Name : B-1@7.0_UCS
Test Performed by : HH
Date Tested : 11/16/11
Data Reduced by : EAS
Date Reduced : 11/18/11

Core Length		Diameter		L/D	Failure Load	Failure Stress	UCS 2:1		Failure Mode		
in	cm	in	cm	Ratio	lbs	psi	psi	MPa			
4.128	10.49	2.062	5.24	2.00	420	126	127	0.9	Structural		
P-wave		S-wave		Dynamic E		Dynamic	Static E		Static	Density, ρ	
ft/sec	m/sec	ft/sec	m/sec	ksi	GPa	ν	ksi	GPa	ν	lb/ft ³	g/cm ³
N/A	N/A	N/A	N/A	N/A	N/A	N/A	N/A	N/A	N/A	104	1.67

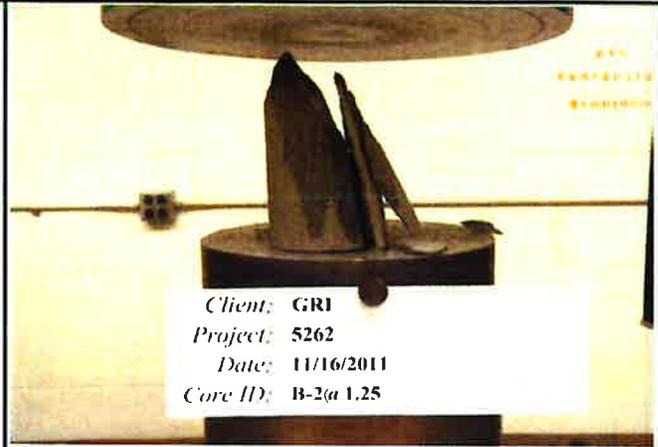
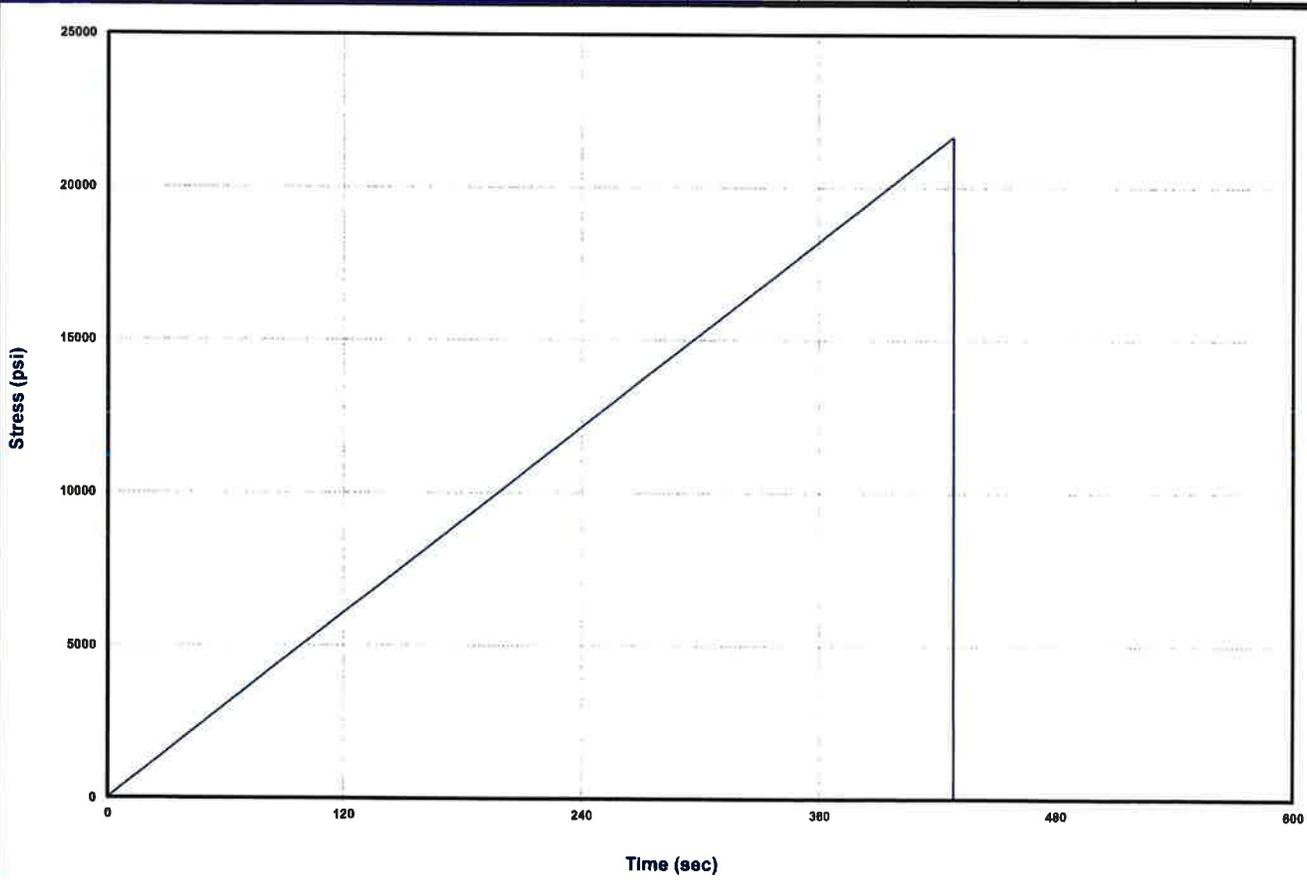
Client : GRI
 Project : 5262
 Location : N/A
 Rock Type : Igneous
 Rock Name : N/A
 Characteristics : N/A
 Core ID : B-2@1.25
 File Name : B-2@1.25_UCS
 Test Performed by : EAS
 Date Tested : 11/16/11
 Data Reduced by : EAS
 Date Reduced : 11/18/11

Core Length		Diameter		L/D	Failure Load	Failure Stress	UCS 2:1		Failure Mode		
in	cm	in	cm	Ratio	lbs	psi	psi	MPa			
4.029	10.23	2.048	5.20	1.97	71,350	21,659	21,815	150.4	Non-Structural		
P-wave		S-wave		Dynamic E		Dynamic	Static E		Static	Density, ρ	
ft/sec	m/sec	ft/sec	m/sec	ksi	GPa	ν	ksi	GPa	ν	lb/ft ³	g/cm ³
N/A	N/A	N/A	N/A	N/A	N/A	N/A	N/A	N/A	N/A	159	2.55

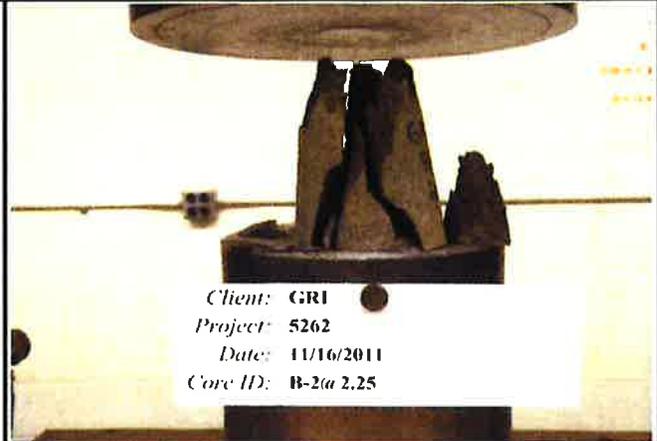
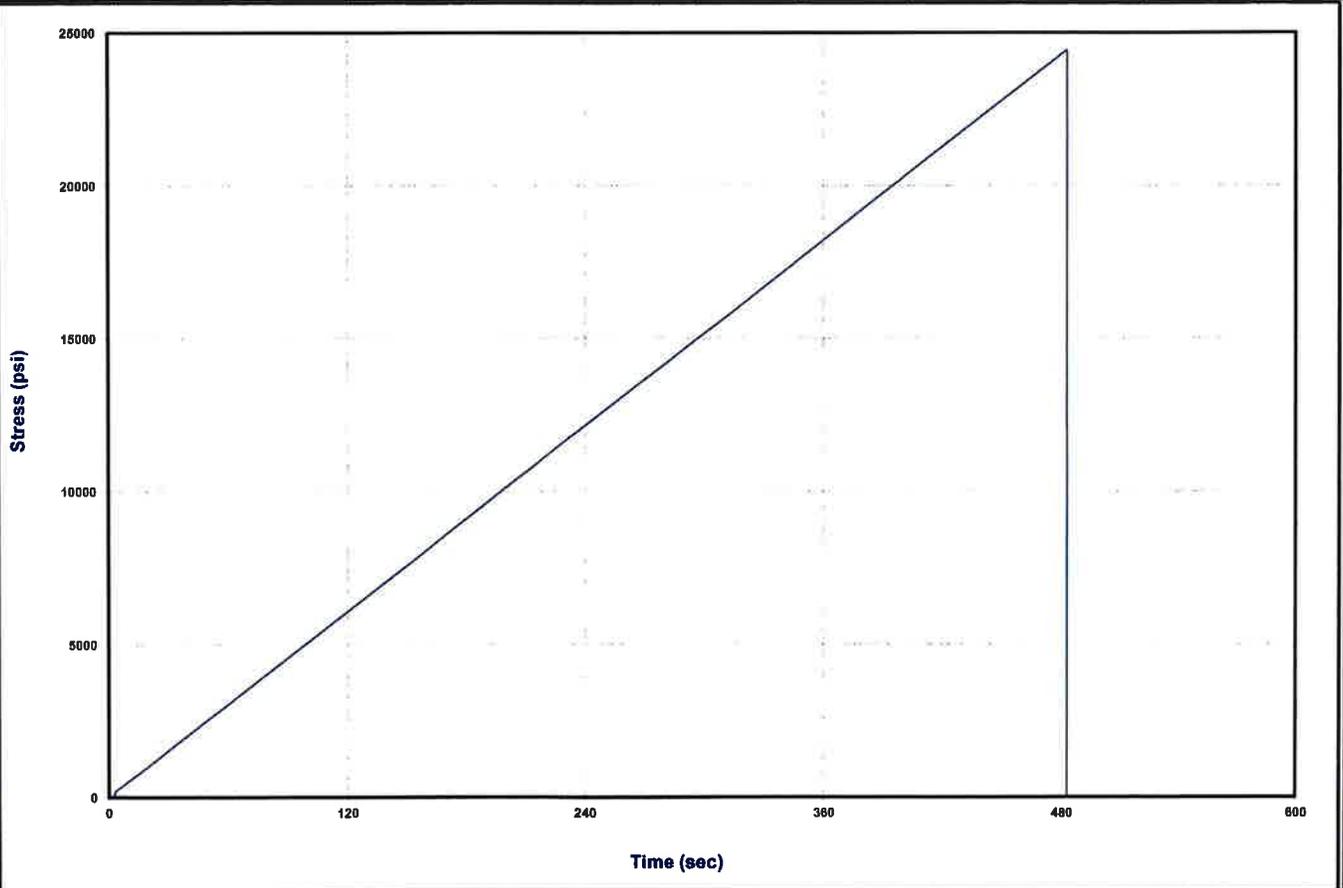
Client : GRI
 Project : 5262
 Location : N/A
 Rock Type : Igneous
 Rock Name : N/A
 Characteristics : N/A
 Core ID : B-2@2.25
 File Name : B-2@2.25_UCS
 Test Performed by : EAS
 Date Tested : 11/16/11
 Data Reduced by : EAS
 Date Reduced : 11/18/11

Core Length		Diameter		L/D	Failure Load	Failure Stress	UCS 2:i		Failure Mode		
in	cm	in	cm	Ratio	lbs	psi	psi	MPa			
3.991	10.14	2.048	5.20	1.95	80,421	24,425	24,575	169.4	Non-Structural		
P-wave		S-wave		Dynamic E		Dynamic	Static E		Static	Density, ρ	
ft/sec	m/sec	ft/sec	m/sec	ksl	GPa	ν	ksl	GPa	ν	lb/ft ³	g/cm ³
N/A	N/A	N/A	N/A	N/A	N/A	N/A	N/A	N/A	N/A	163	2.61

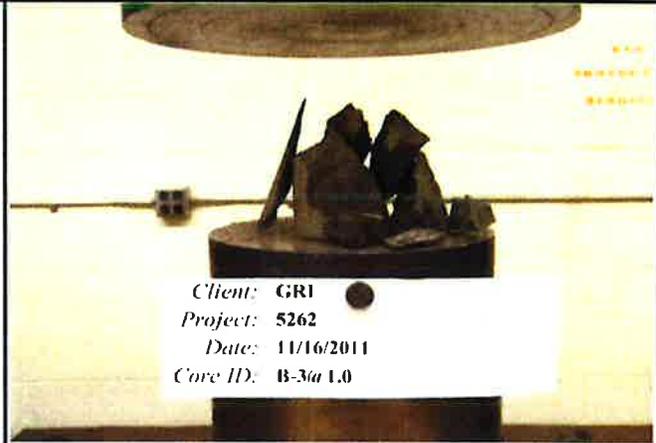
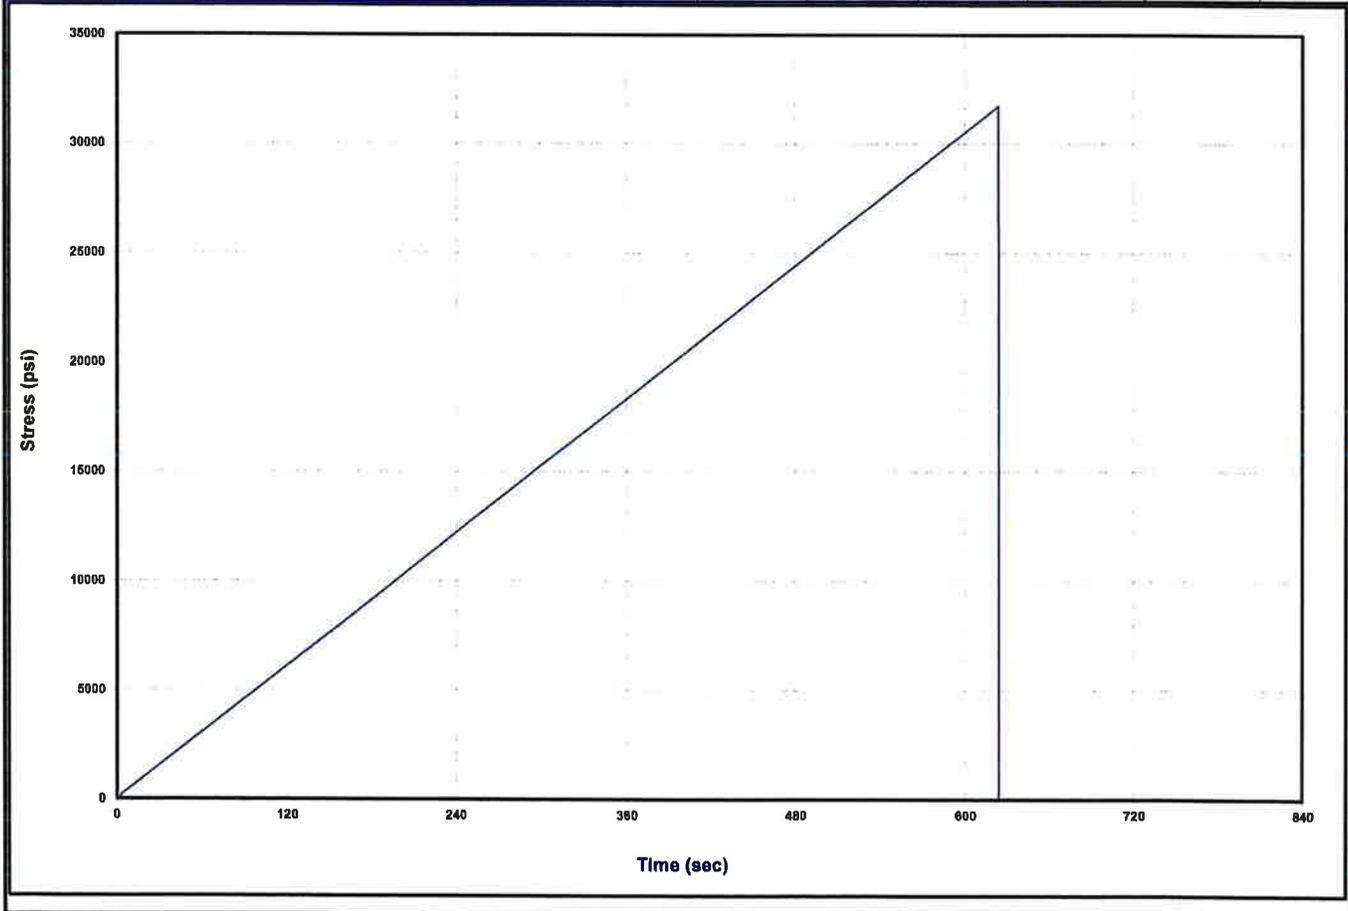
Client : GRI
 Project : 5262
 Location : N/A
 Rock Type : Igneous
 Rock Name : N/A
 Characteristics : N/A
 Core ID : B-3@1.0
 File Name : B-3@1.0_UCS
 Test Performed by : HH
 Date Tested : 11/16/11
 Data Reduced by : EAS
 Date Reduced : 11/18/11

Core Length		Diameter		L/D	Failure Load	Failure Stress	UCS 2:1		Failure Mode		
in	cm	in	cm	Ratio	lbs	psi	psi	MPa			
4.010	10.19	2.043	5.19	1.96	103,970	31,732	31,953	220.3	Non-Structural		
P-wave		S-wave		Dynamic E		Dynamic	Static E		Static	Density, ρ	
ft/sec	m/sec	ft/sec	m/sec	ksi	GPa	ν	ksi	GPa	ν	lb/ft ³	g/cm ³
N/A	N/A	N/A	N/A	N/A	N/A	N/A	N/A	N/A	N/A	172	2.76

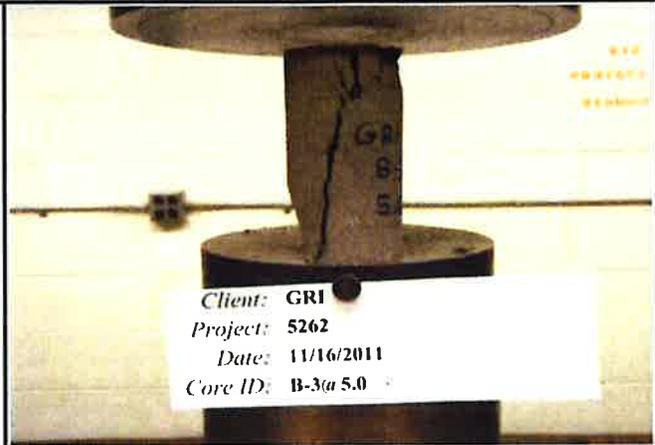
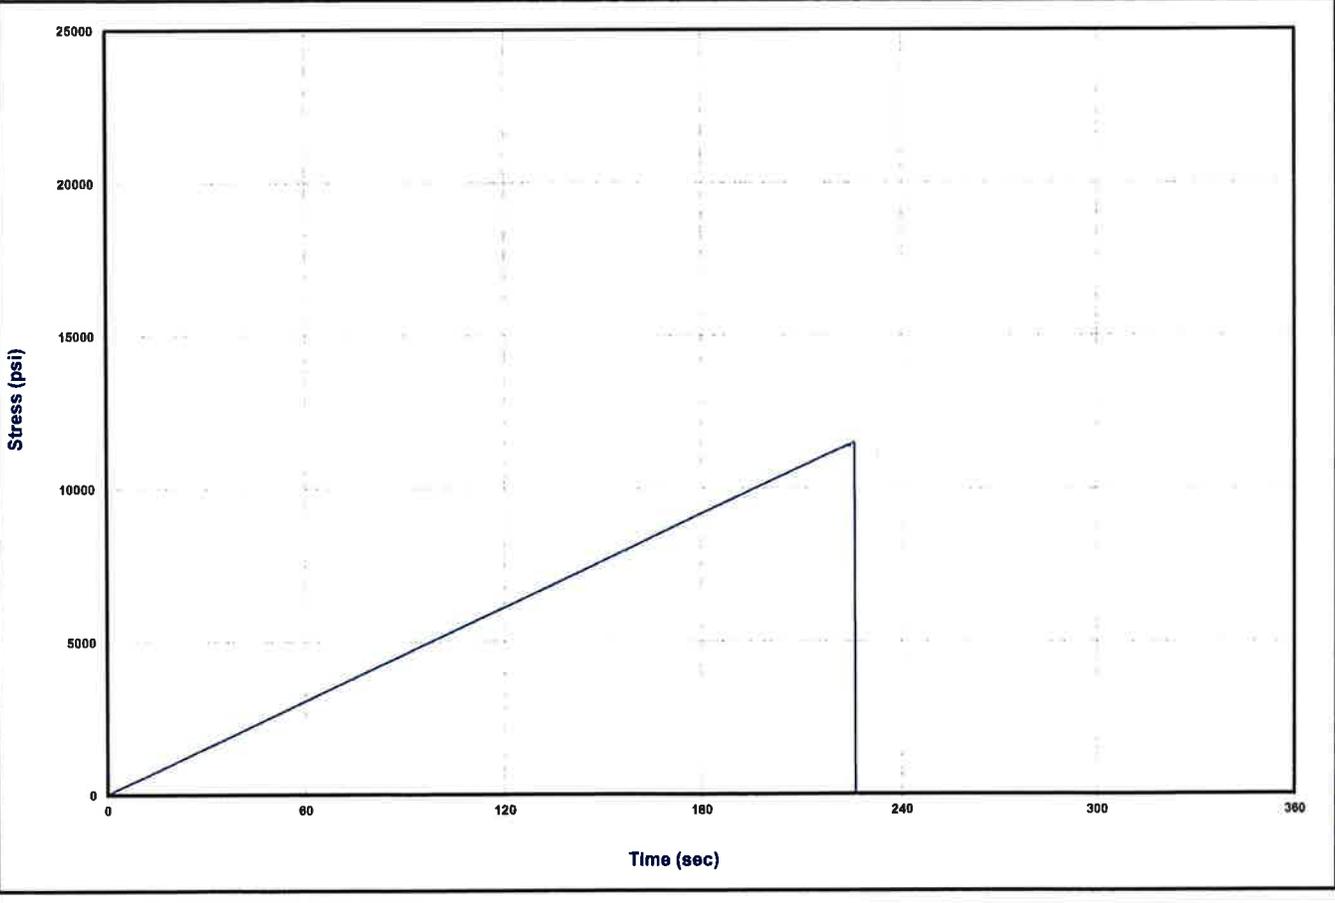
Client : GRI
 Project : 5262
 Location : N/A
 Rock Type : Igneous
 Rock Name : N/A
 Characteristics : N/A
 Core ID : B-3@5.0
 File Name : B-3@5.0_UCS
 Test Performed by : HH
 Date Tested : 11/16/11
 Data Reduced by : EAS
 Date Reduced : 11/18/11

Core Length		Diameter		L/D	Failure Load	Failure Stress	UCS 2:1		Failure Mode		
in	cm	in	cm	Ratio	lbs	psi	psi	MPa			
4.030	10.24	2.043	5.19	1.97	37,624	11,483	11,569	79.8	Non-Structural		
P-wave		S-wave		Dynamic E		Dynamic	Static E		Static	Density, ρ	
ft/sec	m/sec	ft/sec	m/sec	ksi	GPa	ν	ksi	GPa	ν	lb/ft ³	g/cm ³
N/A	N/A	N/A	N/A	N/A	N/A	N/A	N/A	N/A	N/A	155	2.48

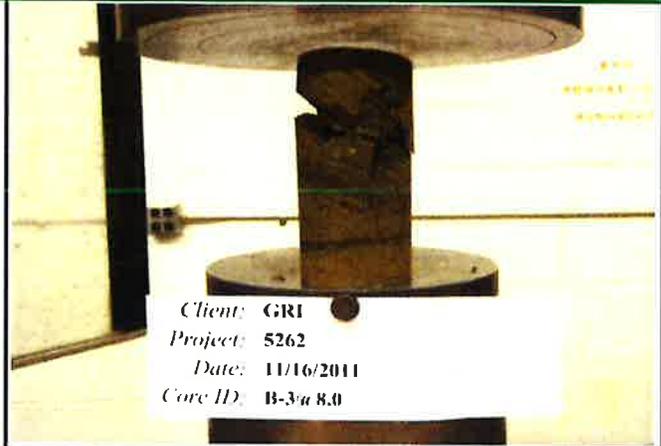
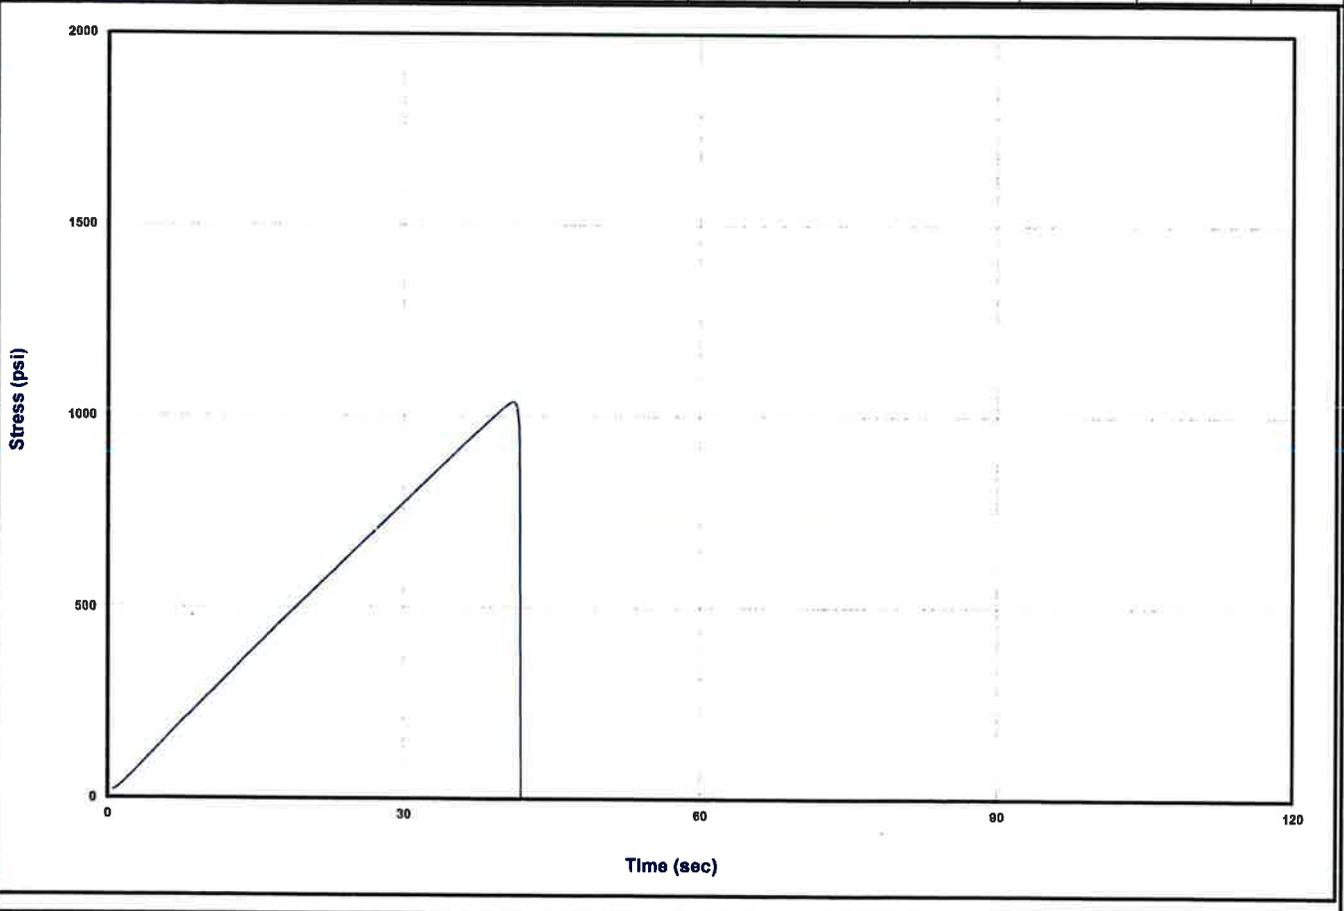
Client : GRI
 Project : 5262
 Location : N/A
 Rock Type : Weathered
 Rock Name : N/A
 Characteristics : N/A
 Core ID : B-3@8.0
 File Name : B-3@8.0_UCS
 Test Performed by : HH
 Date Tested : 11/16/11
 Data Reduced by : EAS
 Date Reduced : 11/18/11

Core Length		Diameter		L/D	Failure Load	Failure Stress	UCS 2:1		Failure Mode		
in	cm	in	cm	Ratio	lbs	psi	psi	MPa			
3.964	10.07	2.041	5.18	1.94	3,394	1,038	1,044	7.2	Structural		
P-wave		S-wave		Dynamic E		Dynamic	Static E		Static	Density, ρ	
ft/sec	m/sec	ft/sec	m/sec	ksi	GPa	ν	ksi	GPa	ν	lb/ft ³	g/cm ³
N/A	N/A	N/A	N/A	N/A	N/A	N/A	N/A	N/A	N/A	118	1.88

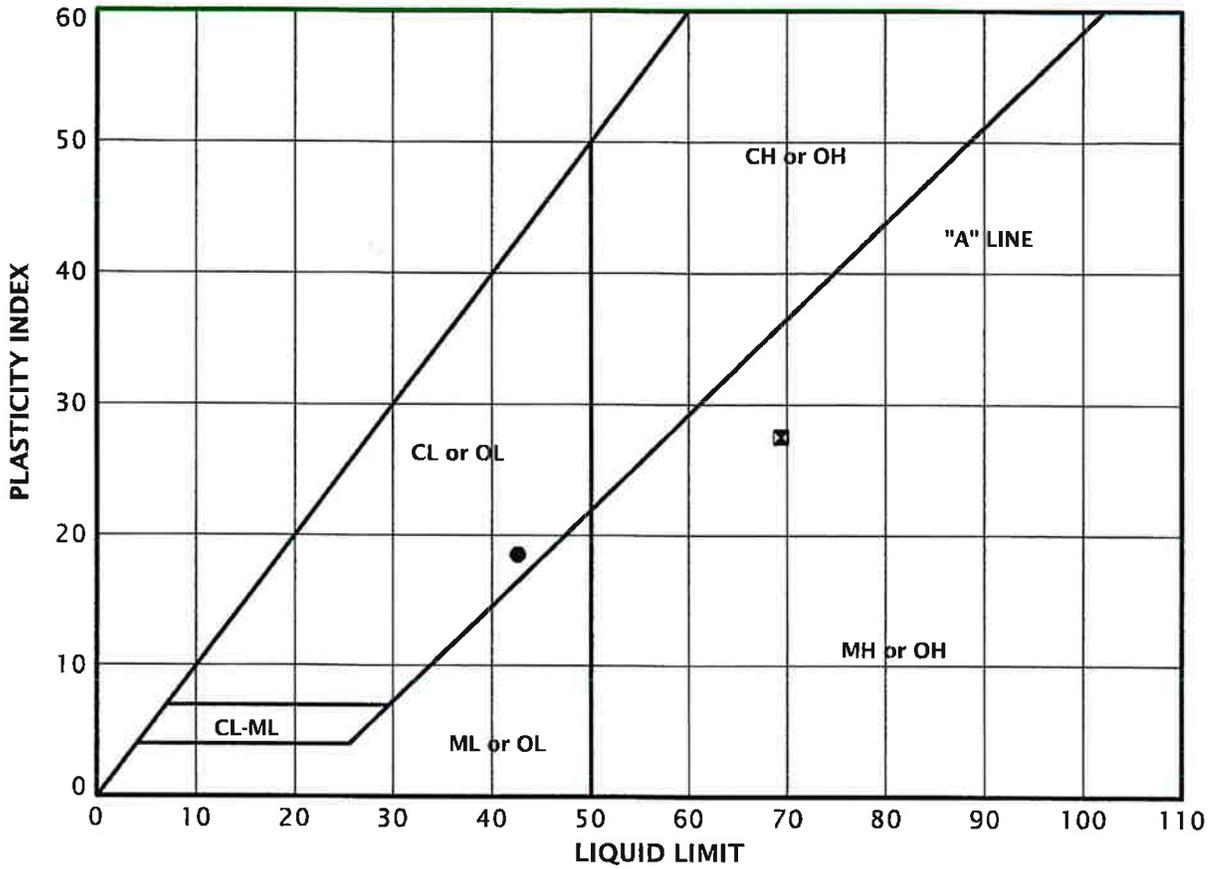
KEY	EXPLORATION NUMBER	SAMPLE DEPTH (FEET)	MOISTURE CONTENT (PERCENT)	LIQUID LIMIT	PLASTIC LIMIT	PLASTICITY INDEX
●	CR-8	1.0	21	43	24	19
☒	CR-8	30.0	46	69	42	27

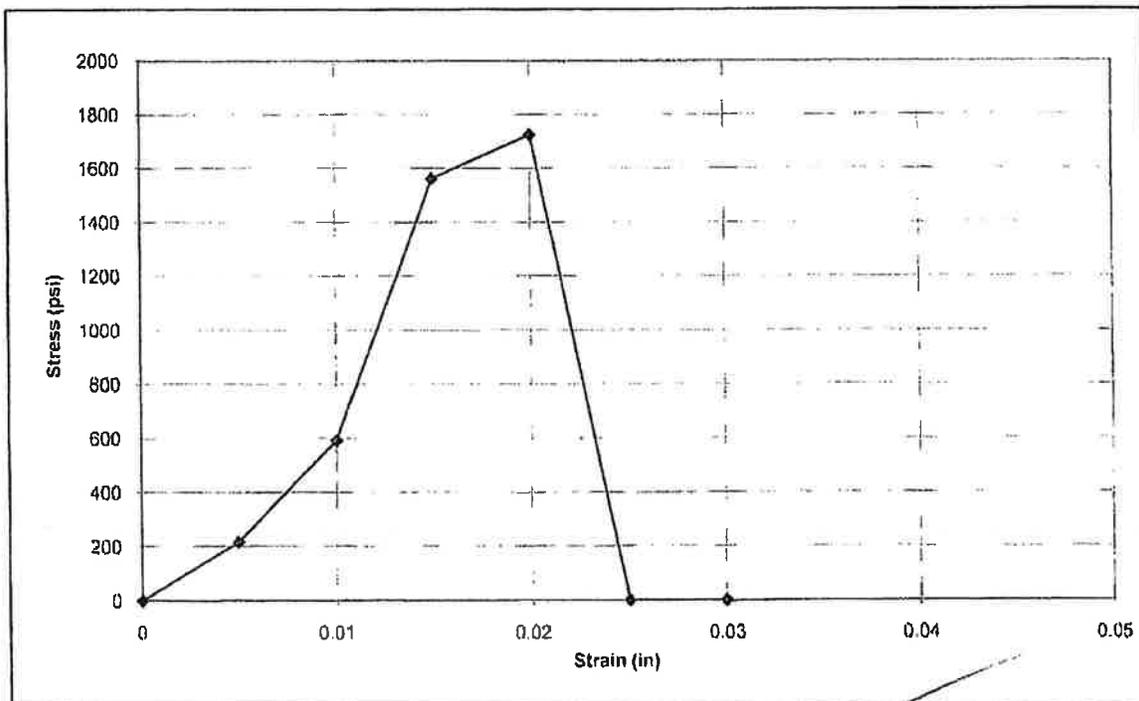
Core shear break from fracture ran full length of core

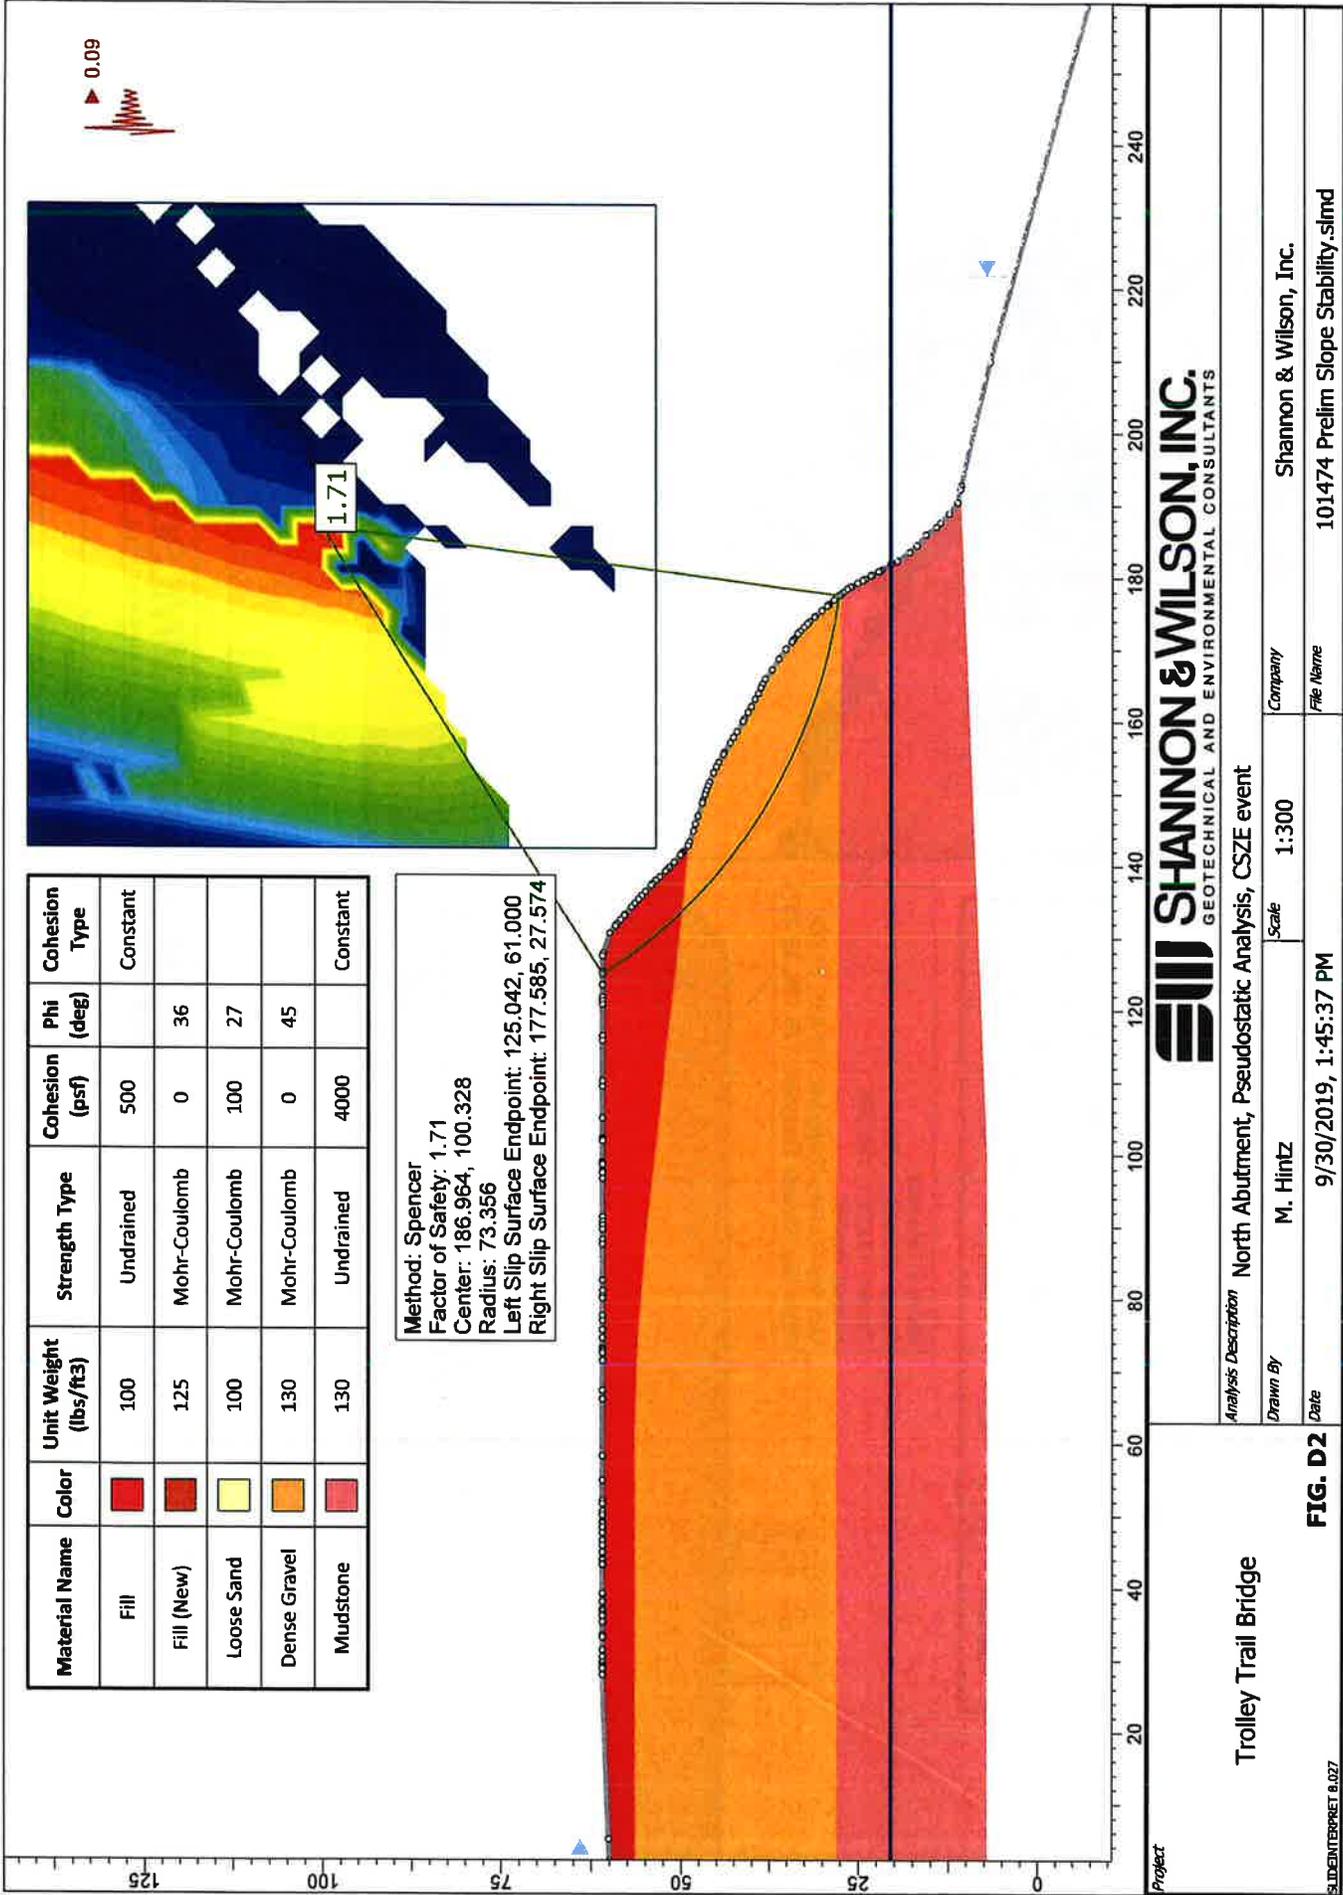
Material Name	Color	Unit Weight (lbs/ft ³)	Strength Type	Cohesion (psf)	Phi (deg)	Cohesion Type
Fill	[Red]	100	Undrained	500		Constant
Fill (New)	[Red]	125	Mohr-Coulomb	0	36	
Loose Sand	[Yellow]	100	Mohr-Coulomb	100	27	
Dense Gravel	[Orange]	130	Mohr-Coulomb	0	45	
Mudstone	[Red]	130	Undrained	4000		Constant
